Multiple First-Floor Collapses at Private Dwelling Cellar Fires

by Deputy Chief James DiDomenico, Division 13 Commander

Long-smoldering fire leads to delayed alarm

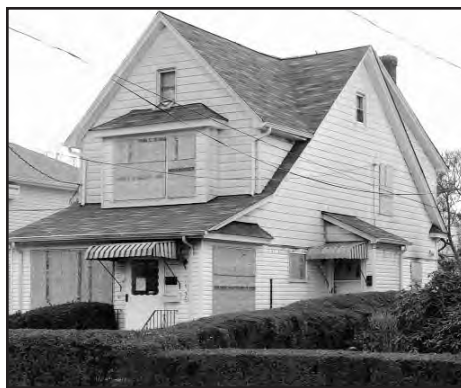
Photo #1--115-30 175th Street. The exposure #4 side entrance to the upper floors. There are very few windows on this side of the building, indicating stairs to the second floor run on the exposure #4 wall.

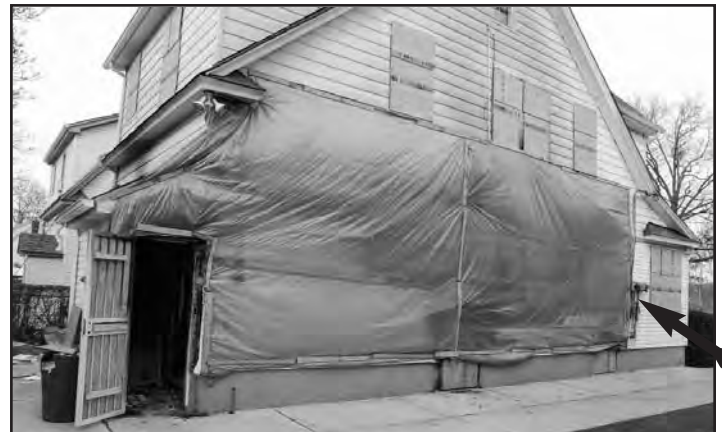
Photo #2--115-30 175th Street. Note the side cellar entrance with a few steps up to the kitchen and half flight down to the cellar. Also note the side cellar windows at ground level. The multiple meters (arrow) indicate multiple apartments.

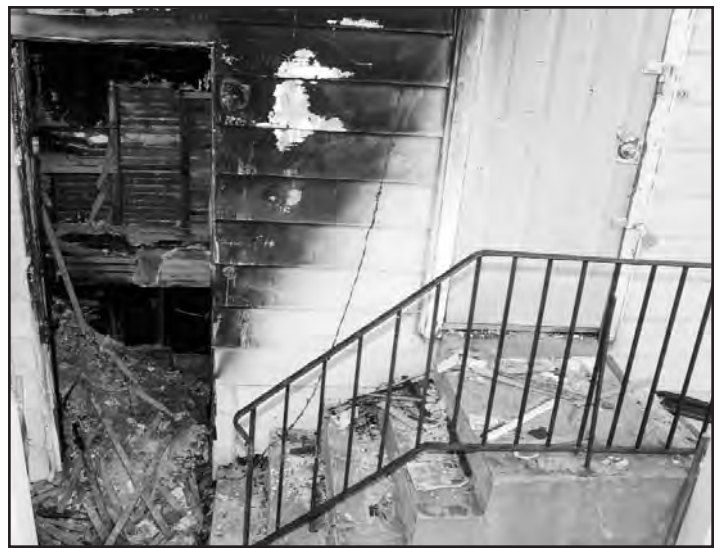
Photo #3--127-23 Hawtree Creek Road. The stoop and side cellar entrance on the same side of the building indicate an exterior entrance to the upper floor.

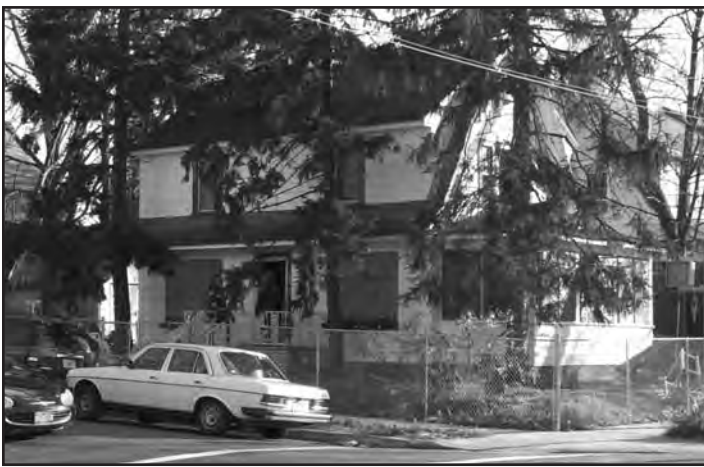
Photo #4--187-02 Newburg Street. Corner view of the private dwelling as units saw building. Heavy fire showed in side cellar window on exposure #2 side cellar windows.
